## Engineer's Report

# SEWER DISTRICT No. 1 Hulett's Landing Sanitary Sewer Collection System Study

Town of Dresden  
Washington County  
New York

Date: October 17, 2025

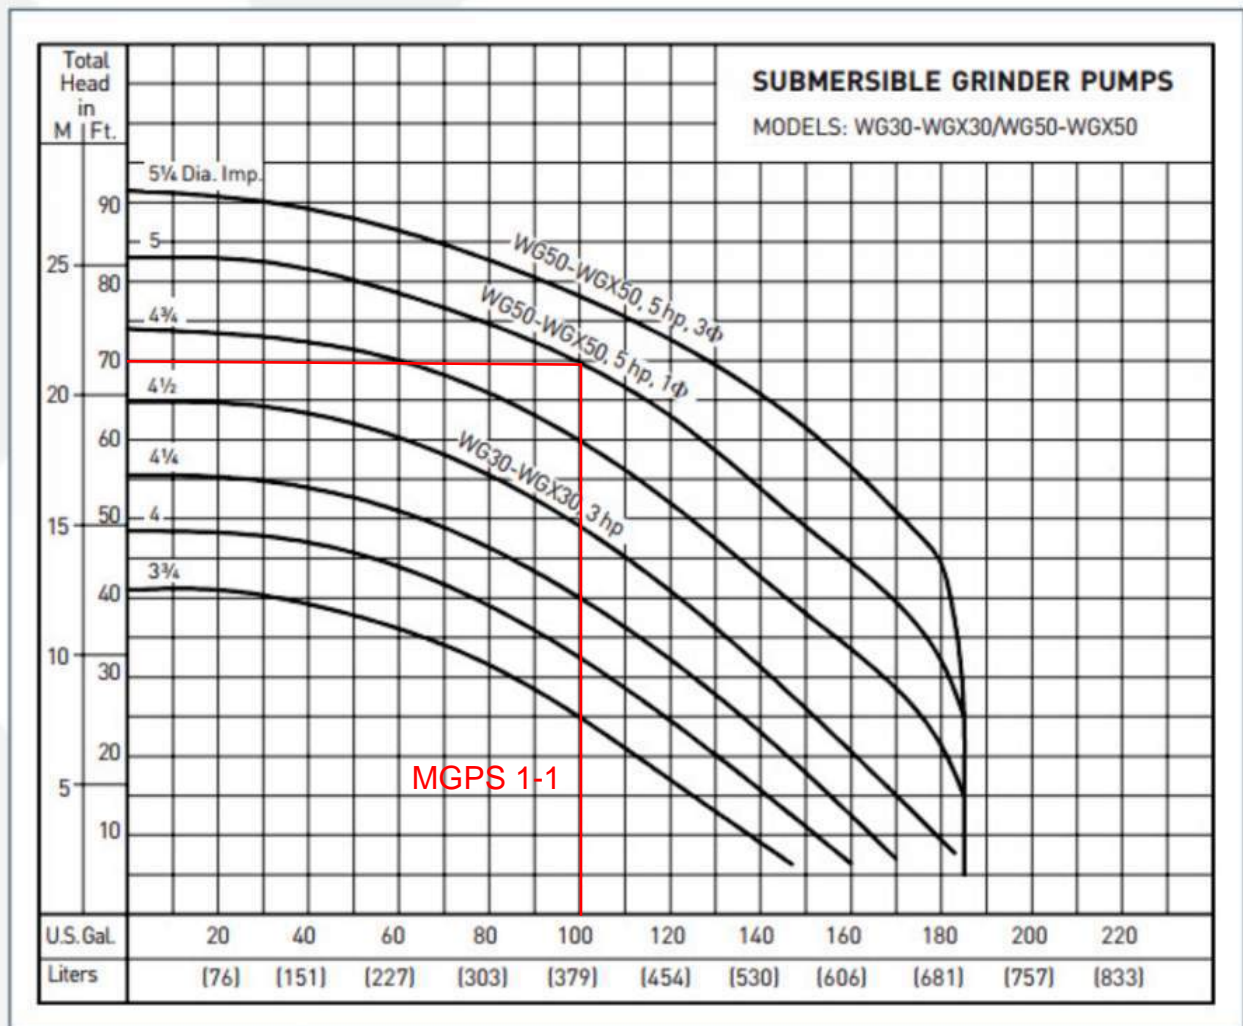
## Myers Model WG50/WGX50 Submersible Grinder Pump Curve

Note: On single phase 5 hp pumps, do not exceed 5" dia. impeller.

All pumps are submersible grinder pumps with solids handling capabilities. Flow capabilities are shown on Pump Curves, which are included in Appendix F. Pumps were originally installed in 1995 and have all been replaced within the last 5-8 years, or more recently as noted. The District currently has one (1) new spare EOne, 1-Hp Pump on site.

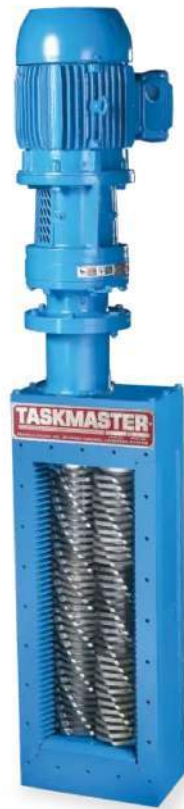
# TASKMASTER® TM8500 Wastewater Grinder

The **TASKMASTER® TM8500** twin shaft grinders provide unsurpassed grinding of wastewater solids, and design features that make them truly unique. These units have proven their capability and unique reliability in installations worldwide. TASKMASTER grinders feature dependable mechanical seals in a cartridge design and CUTTER CARTRIDGE® Technology.

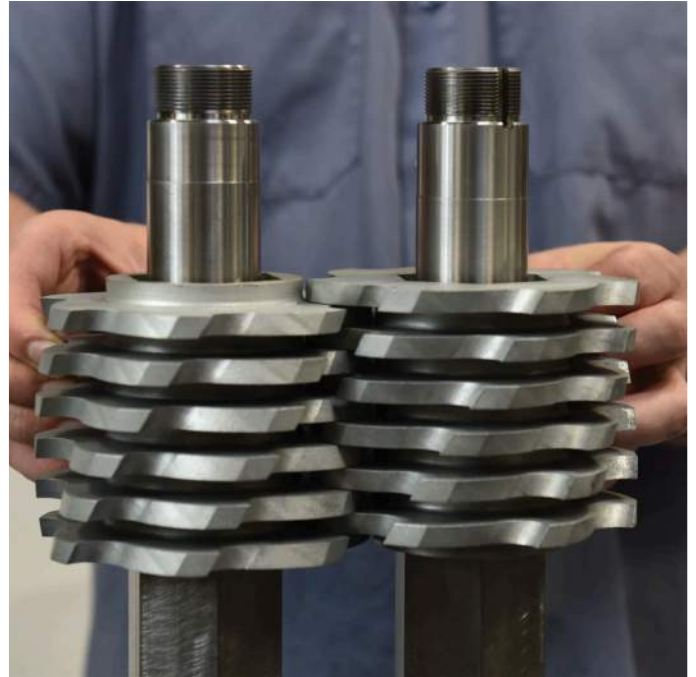
These grinders reduce pump ragging and problems with downstream equipment by finely reducing such solids as rags, plastics, wipes, paper, disposables, fabrics, wood, bottles and much more. They are built for sewage, sludge, septage and screenings applications in either open channel, inline or gravity installations. Each unit is heavily constructed for low vibration and quiet operation.
